Radon Inspection Report

Valerie & Kevin Keslinger
221 West Elm Street
Littleton, NH 03561

Inspection Report Date: 11/06/2019

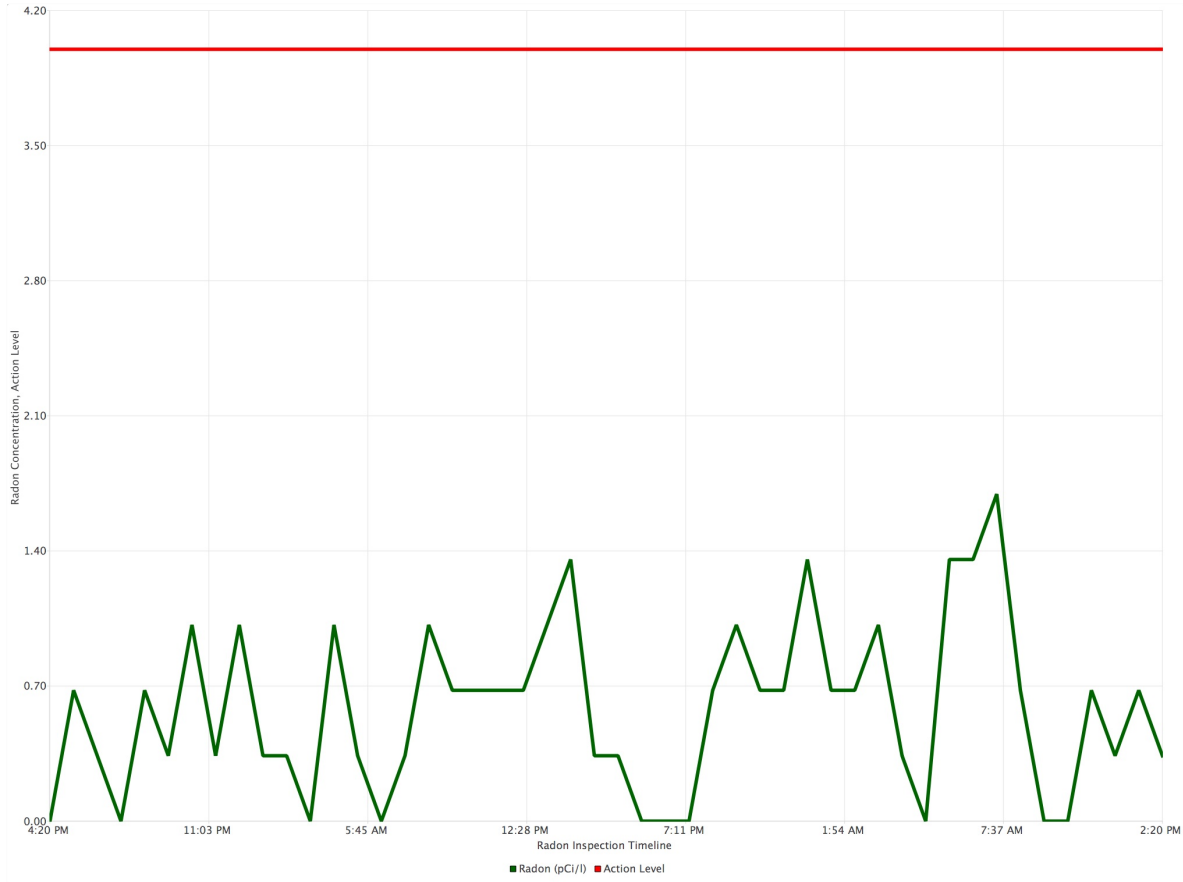
Radon Inspection Chart

0.6 pCi/l

<u>CRM Location:</u>	<u>Start:</u>	<u>Stop:</u>	<u>Interval:</u>	<u>Duration:</u>
Basement	11/01/2019 03:20 PM	11/03/2019 02:20 PM	1 hr	48 hr
 	<u>Min:</u>	<u>Max:</u>	<u>Average:</u>	<u>Measurement Units:</u>
Radon Concentration:	0.0	1.7	0.6	pCi/l
